# New Hampshire Volunteer Lake Assessment Program

## 2003 Biennial Report for Rockybound Pond Croydon

NHDES Water Division Watershed Management Bureau 29 Hazen Drive Concord, NH 03301

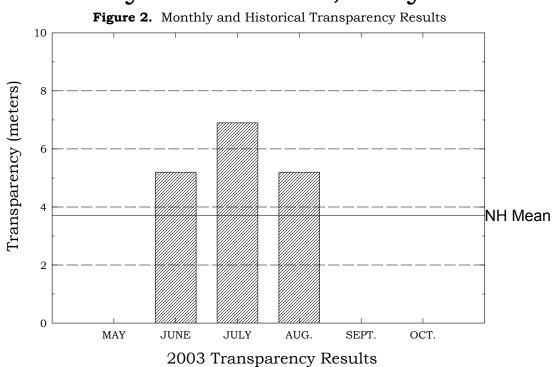
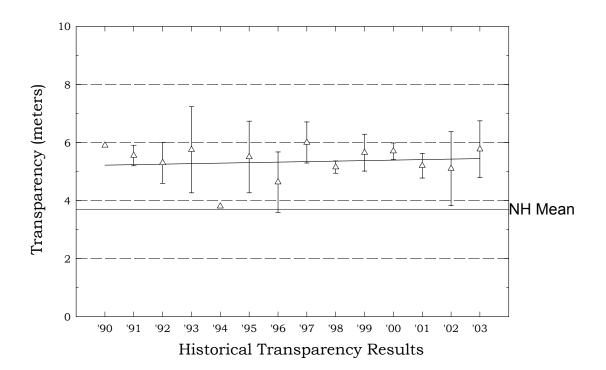
Figure 2 and Table 3: The graphs in Figure 2 (Appendix A) show historical and current year data for pond transparency. Table 3 (Appendix B) lists the maximum, minimum and mean transparency data for each sampling season that the pond has been monitored through the program.

The current year data (the top graph) show that the in-lake transparency *increased* from June to July, and then *decreased* from July to August. The transparency in all three months was *greater than* the state mean.

The bottom graph shows historical annual mean transparencies. In 2003, the mean transparency is *greater than* the state mean.

Overall, the statistical analysis of the historical data (the bottom graph) show that the mean annual in-lake transparency has **not significantly changed** (either *increased* or *decreased*) since monitoring began in **1990**. Specifically, the in-lake transparency has

remained *relatively stable* and has been *less than* the state mean. (Note: Please refer to Appendix E for the statistical analysis explanation and data print out.)

Typically, high intensity rainfall causes erosion of sediments into lakes/ponds and streams, thus decreasing clarity. Efforts should continually be made to stabilize stream banks, pond shorelines, disturbed soils within the watershed, and especially dirt roads located immediately adjacent to the edge of tributaries and the pond. Guides to Best Management Practices designed to reduce, and possibly even eliminate, nonpoint source pollutants, such as sediment loading, are available from DES upon request.

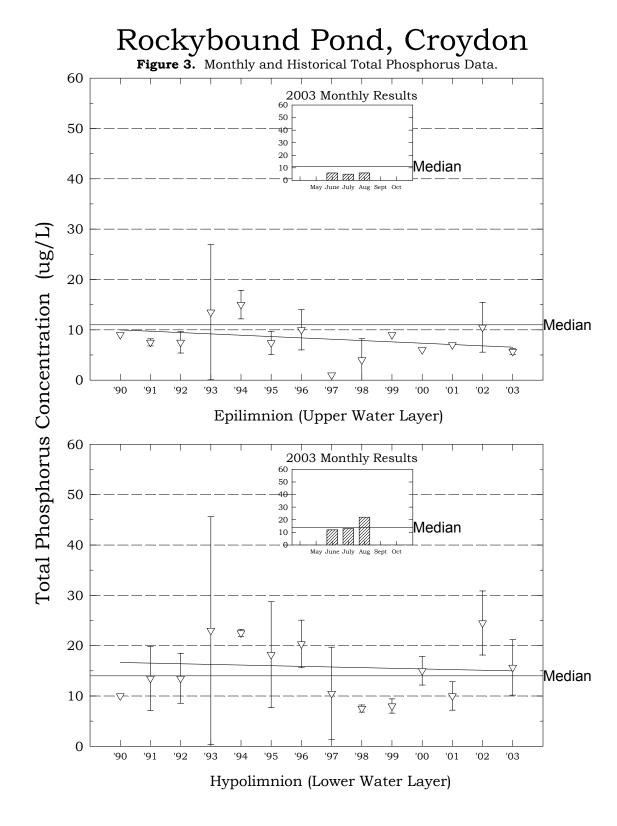
Figure 3 and Table 8: The graphs in Figure 3 (Appendix A) show the amounts of phosphorus in the epilimnion (the upper layer) and the hypolimnion (the lower layer); the inset graphs show current year data. Table 8 (Appendix B) lists the annual maximum, minimum, and median concentration for each deep spot layer and each tributary since the pond has joined the program.

The current year data for the epilimnion (the top inset graph) show that the phosphorus concentration *decreased* from June to July, and then *increased* from July to August. The phosphorus concentration in June, July, and August was *less than* the state median.

The top graph shows historical annual mean epilimnetic phosphorus concentrations. In 2003, the mean epilimnetic phosphorus concentration is *less than* the state median.

The current year data for the hypolimnion (the bottom inset graph) show that the phosphorus concentration *increased* from June to August. The phosphorus concentration in June and July was *less than* the state median while the concentration in August was *greater than* the state median.

The bottom graph shows historical annual mean hypolimnetic phosphorus concentrations. In 2003, the mean hypolimnetic phosphorus concentration is *greater than* the state median.

Overall, the statistical analysis of the historical data show that the phosphorus concentration in the epilimnion (upper layer) and the hypolimnion (lower layer) has **not significantly changed** (either increased or decreased) since monitoring began in **1990**. Specifically, the phosphorus concentration in the epilimnion has remained **less than** the state median while the concentration in the hypolimnion has remained **greater than** the state median. (Note: Please refer to Appendix E for the statistical analysis explanation and data print out.)

One of the most important approaches to reducing phosphorus loading to a waterbody is to continually educate watershed residents about its sources and how excessive amounts can adversely impact the ecology and value of lakes and ponds. Phosphorus sources within a lake or pond's watershed typically include septic systems, animal waste, lawn fertilizer, road and construction erosion, and natural wetlands.
